Lake Norman Vegetation Survey Report

October 2024

North Carolina State University
Aquatic Plant Management Program
Raleigh, NC 27607

Duke Energy
Water Resources Group
Huntersville, NC 28078

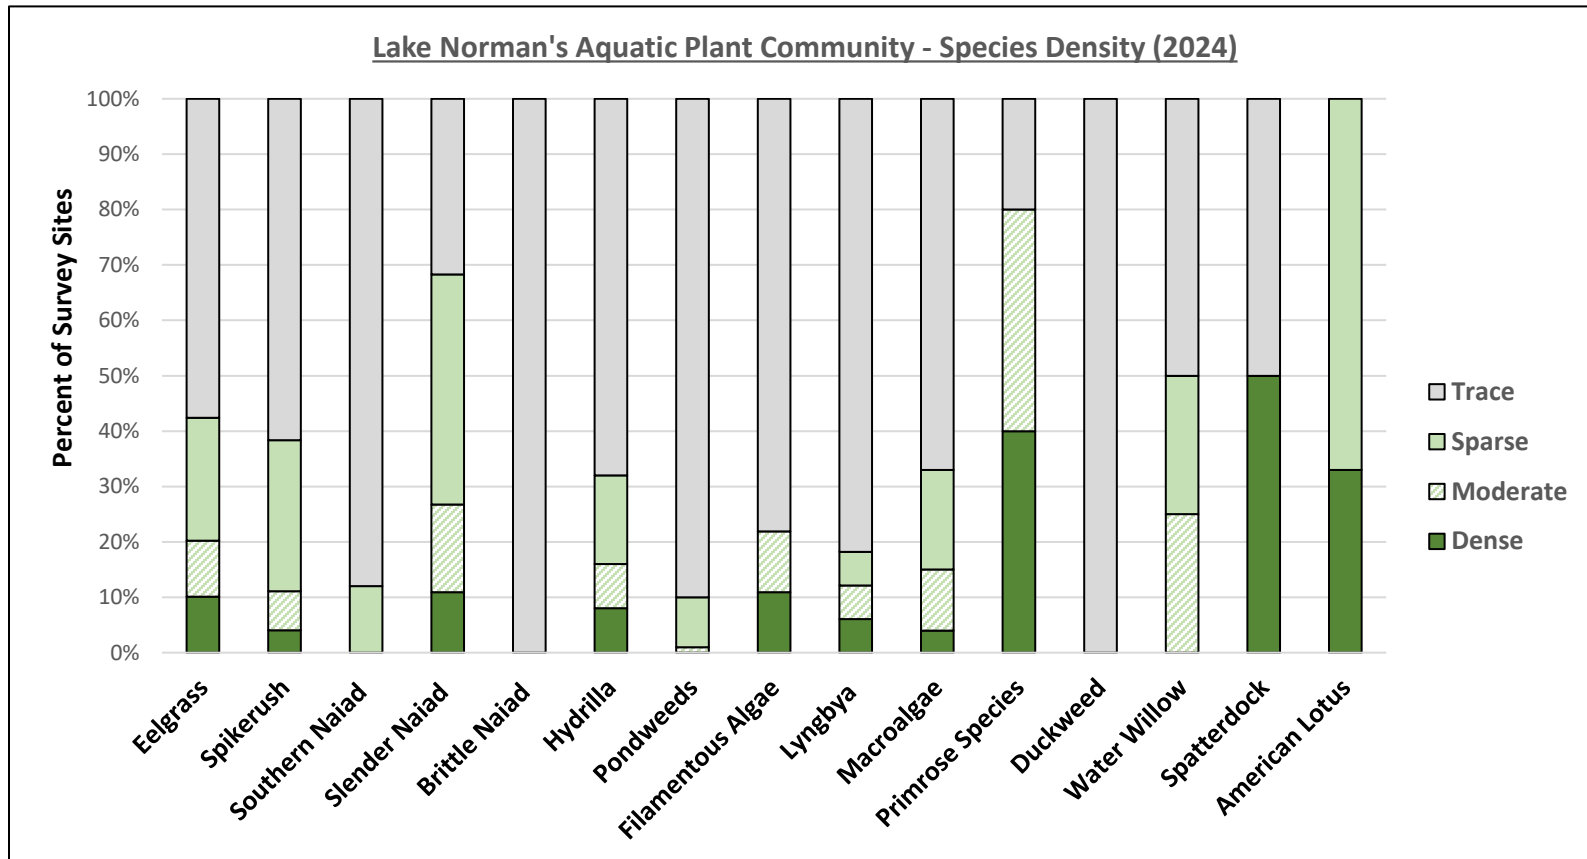
Figure 3. Growth levels displayed by aquatic plant species were ranked as trace, sparse, moderate, or dense at NCSU survey sites during the 2024 vegetation survey. The varying levels of growth displayed by individual species are shown as a percent of all survey sites in which that particular species was present.

The most common species present at Lake Norman in 2024 was spikerush (*Eleocharis baldwinii*), found at 537 (29%) total survey points (Table 1, Figure 6). At most sites where found, spikerush was noted in trace abundance (Table 1; Figure 3). Most dense spikerush growth occurred in the northern section of Lake Norman in 2024 (Figure 6). Spikerush has consistently been one of the most common species at Lake Norman at NCSU survey sites since 2018 (Table 2).

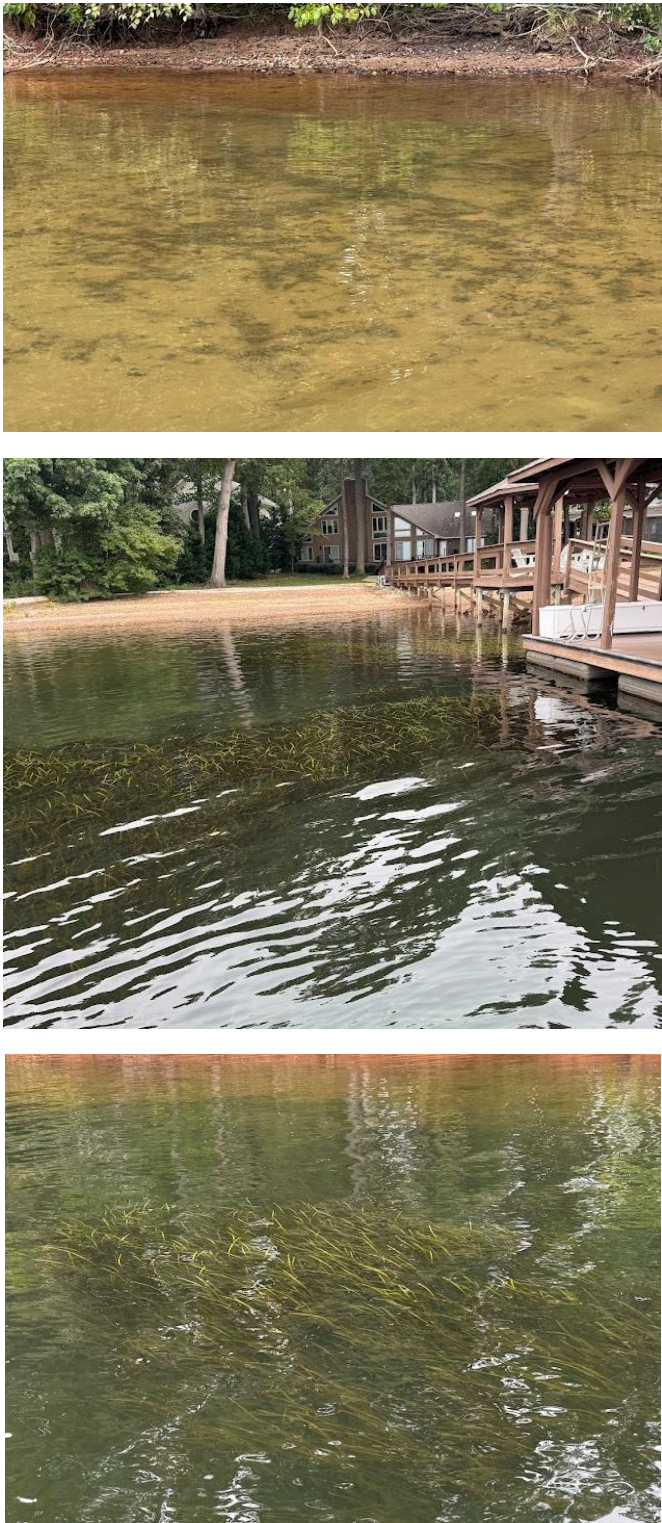
Figure 9: Examples of eelgrass growth in Lake Norman during the 2024 survey.

The eelgrass population continues to increase in distribution and abundance at Lake Norman (2021: 2 Points, 2022: 16 points, 2023: 39 points, 2024: 58 points) (Table 2; Figure 4). During the 2024 survey, eelgrass was noted to be dense at many sites in the Ramsey Creek arm (Figures 8 and 9), but was more sparsely growing at surveyed areas north of the Ramsey Creek section. We estimate that there are 94 acres of eelgrass in Lake Norman in 2024.

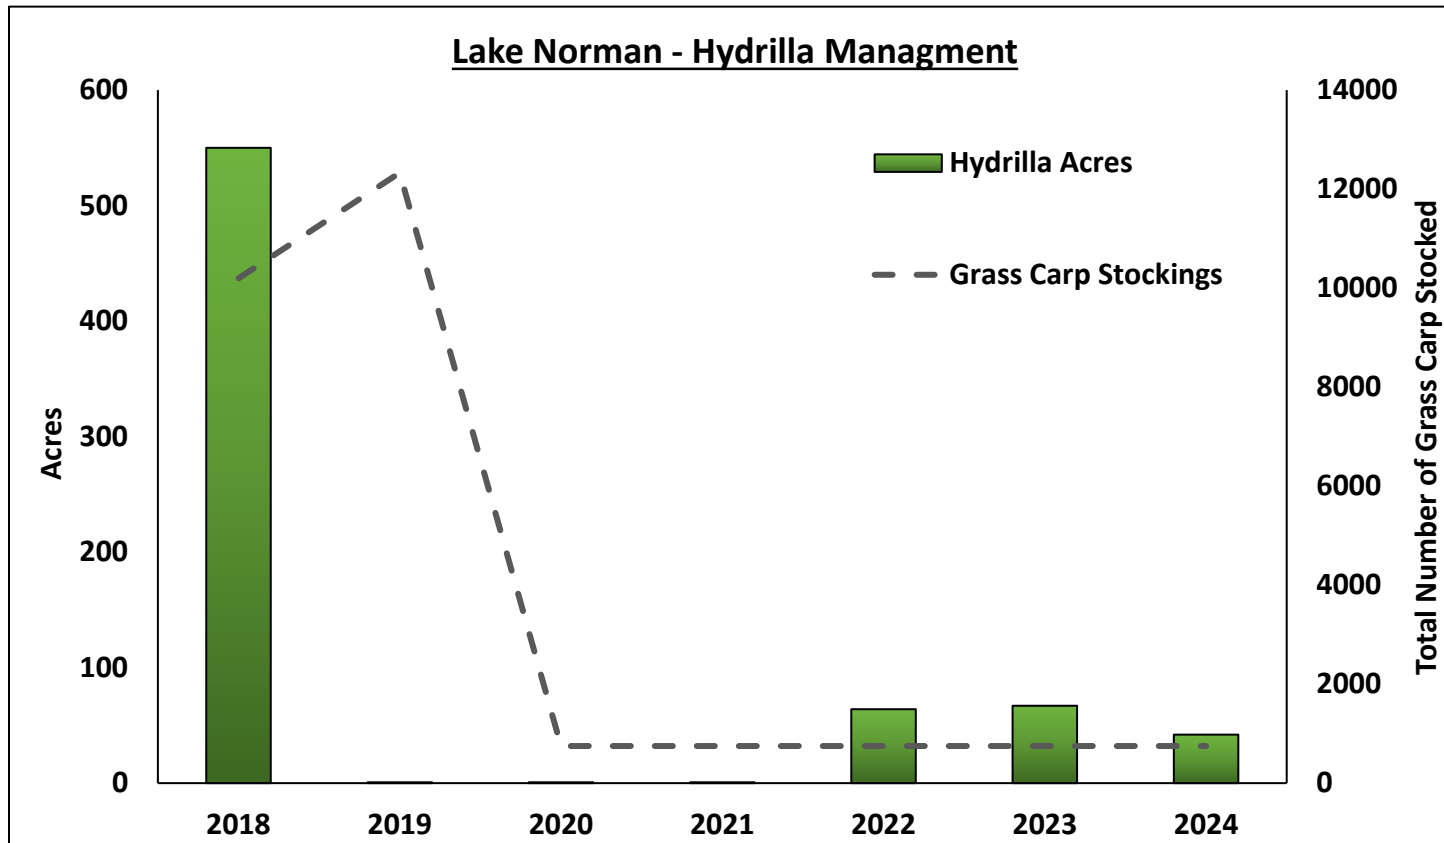
Figure 18: Estimated standing acreage (bars) of hydrilla and total number of grass carp stocked (line) in Lake Norman between 2018 and 2024.

Hydrilla was present at 25 total survey points at Lake Norman during the 2024 survey (Table 1, Figure 7). Of these, 7 occurred below the Highway 150 bridge at the sites surveyed by NCSU, an increase from 3 sites documented in 2023 (Table 2). Hydrilla was most frequently present in trace abundance (68% of points), followed by sparse at 16% of points, and moderate or dense abundance at 8% each (Figure 3). The only areas where moderate or dense growth occurred was in the upper end of the lake, above Buffalo Shoals Road (Figure 7). In 2023, hydrilla in this region was even more widespread, but active management that occurred during the 2024 growing season likely suppressed growth (DEQ 2024). Established hydrilla growth was also noted just south of the Highway 150 Bridge in a creek arm located to the west of the Lake Norman Marina. Documented hydrilla at all other survey sites south of the Highway 150 Bridge were recorded as trace abundance, and as such, only floating fragments or small plant stems were present in these areas. Based on our data, we estimate that 43 acres of Lake Norman's shoreline supported hydrilla growth in 2024. With these results, we conclude that the hydrilla population remains at low levels throughout Lake Norman and continued grass carp stockings are effectively suppressing the total standing acreage (Figure 18).
